# **THE VULNERABILITY OF NEW ZEALAND LIFELINES INFRASTRUCTURE TO ASHFALL**

**A thesis submitted in partial fulfilment of the requirements  
for the Degree of Doctor of Philosophy  
in Hazard and Disaster Management  
in the University of Canterbury**

**Scott Trevor Barnard  
2009  
Department of Geological Sciences**

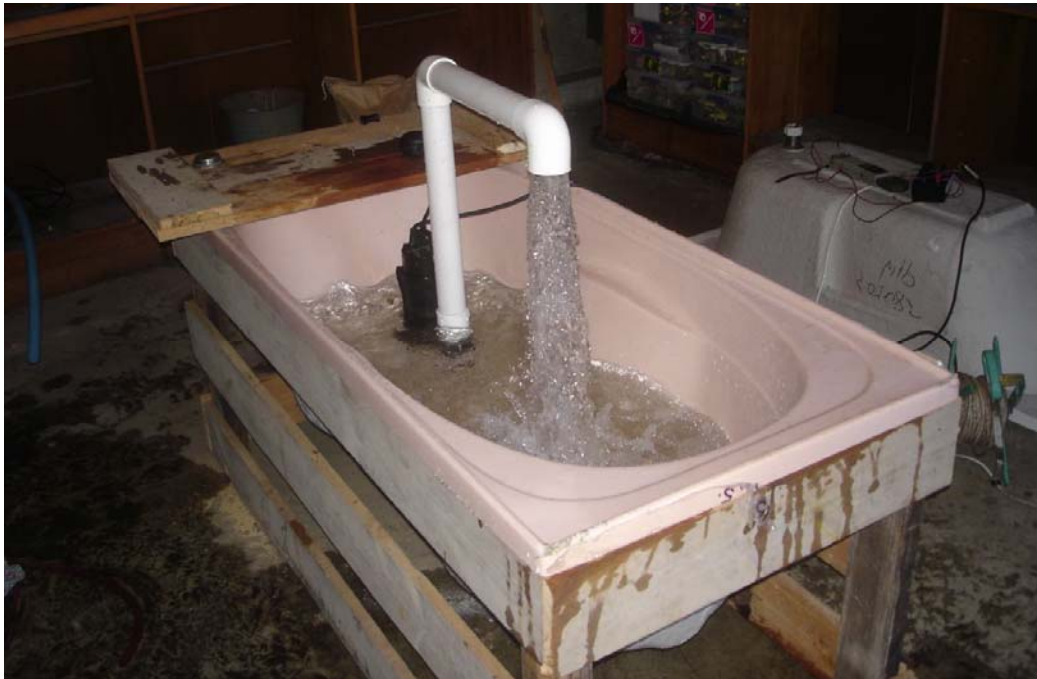
*Figure 6.5: Effluent pump test set up shown during initial clean water test*

Prior to testing, the pump was carefully photographed and the impeller was measured and weighed. This enabled a comparison of the pump pre and post-testing. In this way the amount of wear sustained could be established. Other parameters monitored included the output of the pump (litres per second), the pH of the fluid being pumped and the concentration and grainsize of the ash. The current drawn by the pump was also monitored, but this did not fluctuate beyond normal levels during the course of the experiment. As the objective of this test was to determine the effects of effluent pumps being subjected to volcanic ash, the shape of the sump was not important. The sump simply needed to contain the ash-water mix and allow it to be recirculated. An old bath was used, and the effluent pump placed at one end. A pipe leading from the outlet directed the water back to the other end of the bath (figure 6.5). As the pump displaced approximately 9 litres of fluid per second, most of the ash remained in suspension, and only minor amounts of sedimentation occurred.

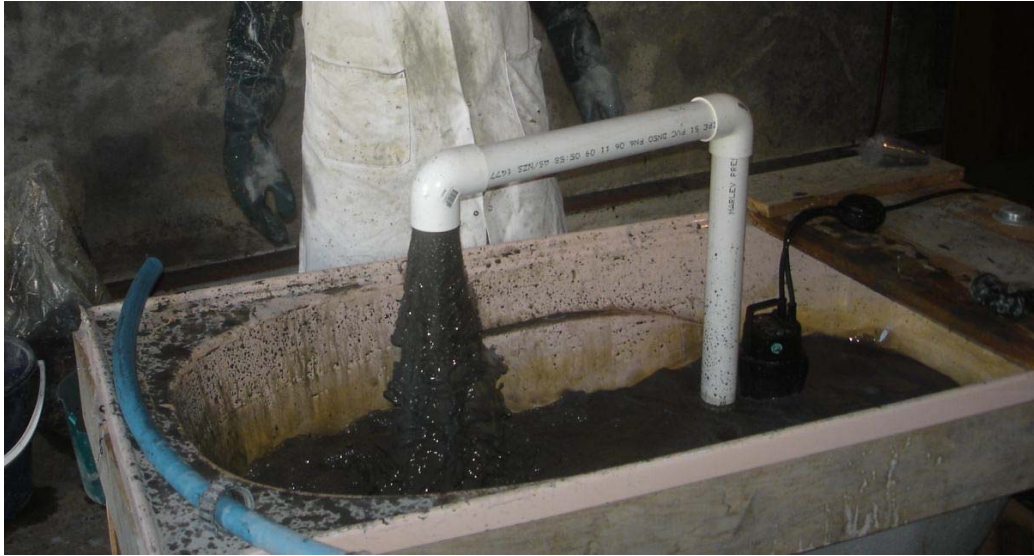
*Figure 6.6: Circulating ash laden water through the Zenit effluent pump.*

As illustrated by table 6.1 initial results indicated no drop off in performance. The pump continued to operate well, and pump at the same rate as it had prior to testing. Variations in the output are more likely due to small errors in measurement than actual changes in flow rate. Figure 6.6 illustrates the experiment in progress.

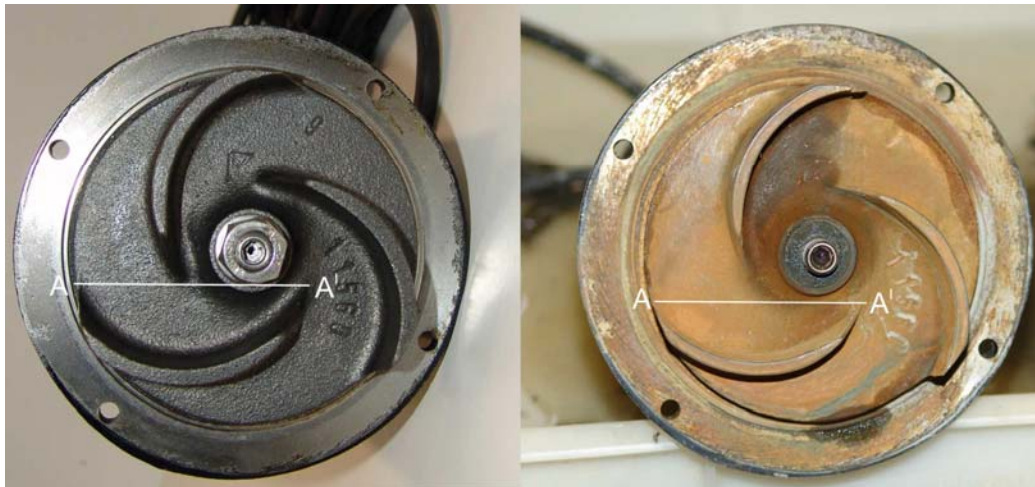
*Figure 6.7: Pump impeller pre testing and after ~29 hours of testing. Impeller blade measurements illustrate the extent of abrasion; A-A' was 65 mm pre testing and 62 mm post test.*

At the end of this test the pump was removed and inspected, to determine if any detrimental effects had taken place. It was found that significant corrosion and abrasion had occurred, as illustrated in figures 6.7 & 6.8

The impeller had been abraded both on its base and blades. Its diameter had decreased slightly, from an initial 101 mm to 99.3 mm. The impeller blades had also decreased in width, the tips of the blades were especially worn (figure 6.8). The distance between each end of the base of each blade was 65 mm pre testing, as illustrated in figure 6.7. A-A<sup>1</sup> was 62 mm after these tests, the other blades measured 62.8 mm and 63 mm. All paint was worn away from both the impeller and the inside of the housing. Pitting was evident on impeller blade surfaces, though it cannot be ruled out that this was not present before testing, as in new condition paint obscured the surface.

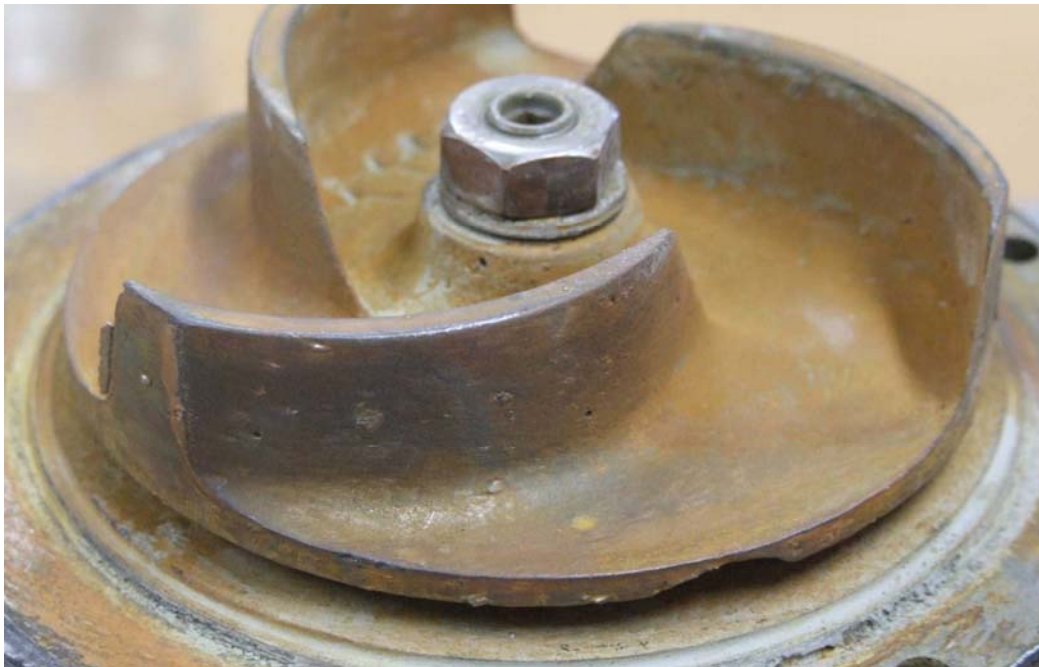
*Figure 6.8 Impeller after ~29 hours testing, note wear on the tips of the blades.*

This level of wear was judged to be consistent with what would normally be seen after 1-2 years of pumping cowshed effluent (H Baker, pers. comm., 2008). Total run time from new had been just over 29 hours. Therefore while the pump had kept functioning it had been subject to extremely accelerated wear.

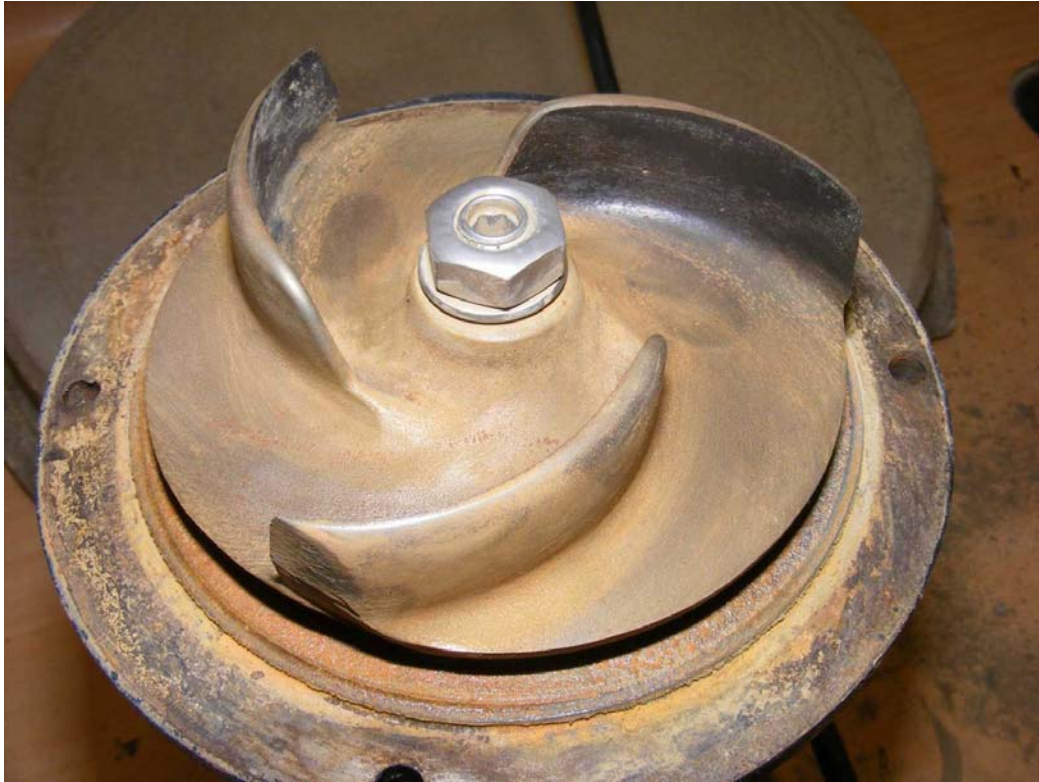
*Figure 6.9: Impeller after 85 hours testing, note the stamped serial number is now not visible.*

For this first part of the longer duration test the pump ran for 56 hours. Inspection at the conclusion of this test revealed severe abrasion to the impeller, and increased levels of corrosion. The impeller blades were again shortened. The initial 65 mm length for each of the 3 blades described in figure 6.7 now measured 55.8 mm, 56.3 mm and 55.1 mm respectively. The serial number of the impeller, which was stamped into the cast iron surface, had also been worn away, indicating the base of the impeller was also subject to erosion (figure 6.9).

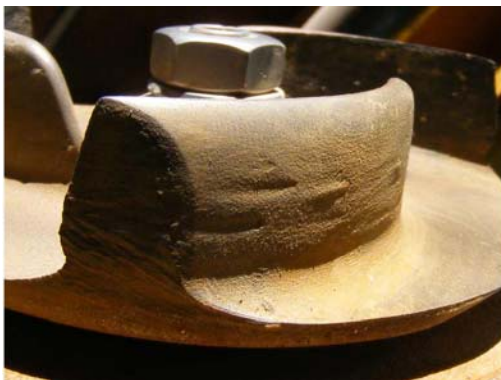
*Figure 6.10: Pitting on the surface of the impeller blades*

Pitting on the impeller blades had also increased (figure 6.10). It was now obvious that the mass of the impeller had decreased, as it was noticeably lighter. It was weighed and found to be 310.6 grams. Initial weight before testing was 448 grams. This loss of over 30% of it's mass represents severe wear for such a short length of time (total test time was now 85 hours).

Minor wear was also evident on the interior of the impeller casing, as was increased corrosion. Surface rust was visible on both the impeller and the interior of the pump housing (figures 6.10 & 6.11). Corrosion and wear were especially noticeable behind the impeller, and on the back of the impeller itself. Ash was visible around the shaft of the impeller, behind the sleeve around the spring holding the seal ring. This meant that ash would be in contact with the seal which separated the motor and electrics from the wet impeller area, potentially abrading both shaft and seal (figure 6.12).

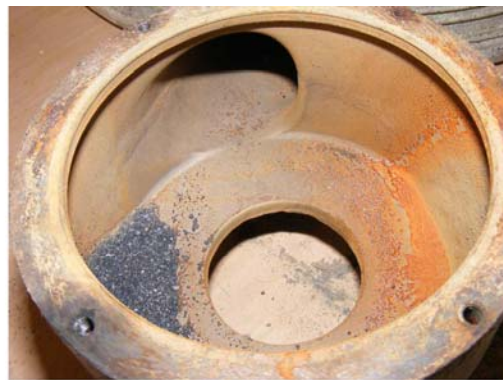
*Figure 6.11: Impeller casing interior, showing minor abrasion (smoothed internal edges) and increased corrosion.*

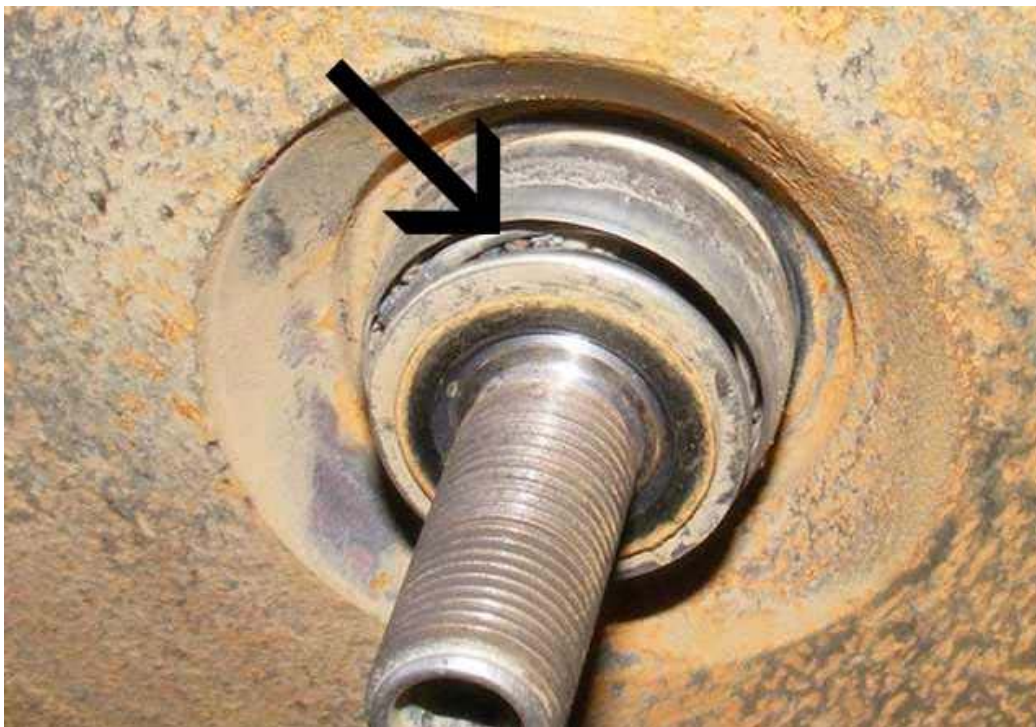
*Figure 6.12: Arrow indicates ash visible behind the sleeve rubbing against the shaft and seal.  
Impeller removed for inspection and photograph*

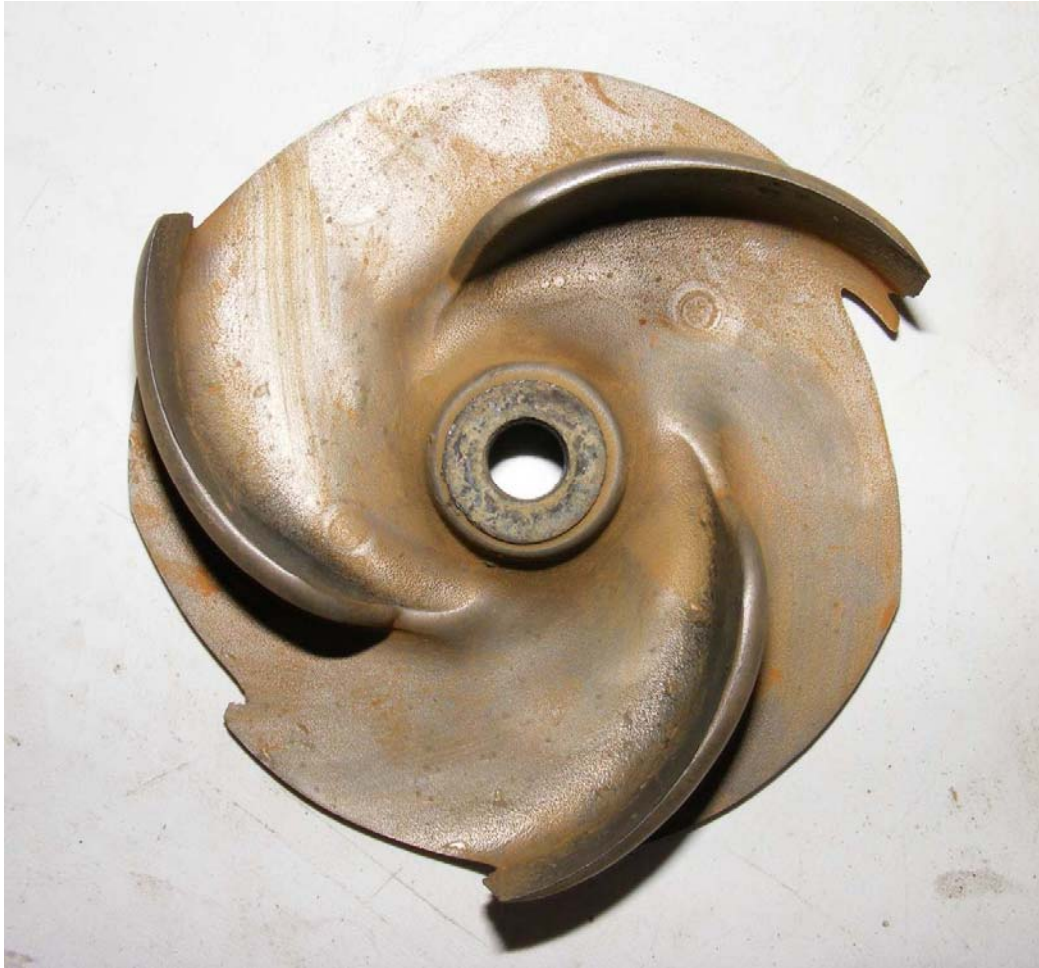
*Figure 6.13: Heavily eroded impeller after 109 hours of testing*

After inspection and reassembly, testing continued. The pump was run for a further 24 hours. As expected, increased wear was again seen. Most significantly, the impeller base had begun to wear through at the thinnest points. These had started as small indentations on the back of the impeller but had increased in size through abrasion during testing (figures 6.13-6.14).

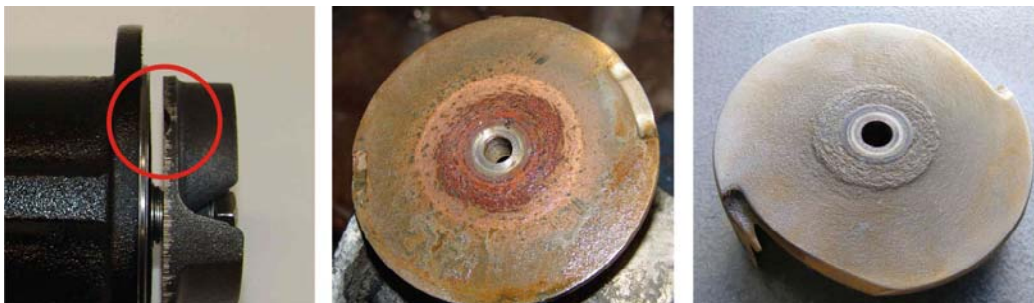
*Figure 6.14: Rear views of the impeller showing the increase in erosion in the rear indentation. Images were taken (from left to right): pre testing, after 29 hours, after 109 hours.*

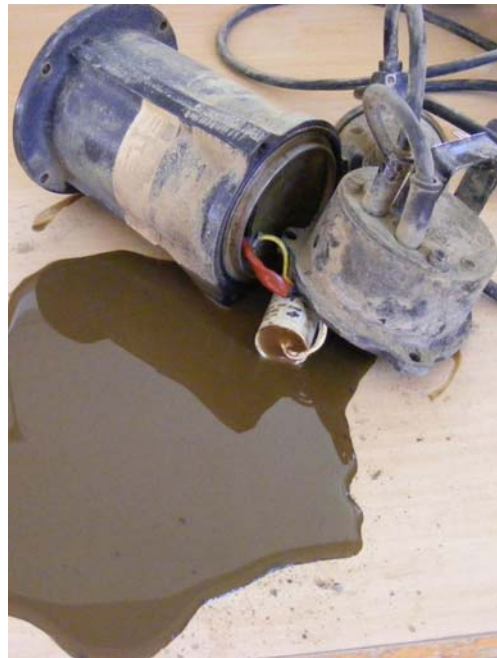
*Figure 6.16: Pump at end of testing. The puddle is all from the interior of the pump, which should be dry.*

The loss of much of the impeller represented a significant decrease in the efficiency of the pump. The length of the 3 blades described in figure 6.7 now measured 52.0 mm, 53.2 mm and 52.9 mm respectively, approximately 80% of their original length. Flow rate was again measured, and found to be 7.5 L/s, the original flow rate was ~9 L/s. Testing resumed in order to determine how long it would take until complete pump failure occurred. This happened only 3 hours later, not because of impeller wear but from failure of the seal separating the electric motor from the impeller and wet area. The seal itself was made from silicon carbide (9 on Mohs scale of hardness), this survived without any signs of wear. The stainless steel impeller shaft however had suffered pitting corrosion, especially between the seal and the shaft. This allowed ash to work its way past the seal. It then became trapped under the seal ring (situated above the mechanical seal), wearing a groove into the metal shaft (figure 6.15). After 112 hours of testing, ash and water broke through into the electric motor, causing the pump to fail (figure 6.16). This failure created an electrical short that blew a fuse in the wall socket.

The failure effectively destroyed the pump. The pump had a design life of 20 years, and was designed to handle noxious substances like effluent, but was not robust enough to cope with volcanic ash. Even without the failure of the seal, the severe abrasion to the impeller would have made the pump inoperative within a few more hours of testing. By the end of testing the impeller weighed 273.8 grams; 39% of its original mass had been removed by abrasion.

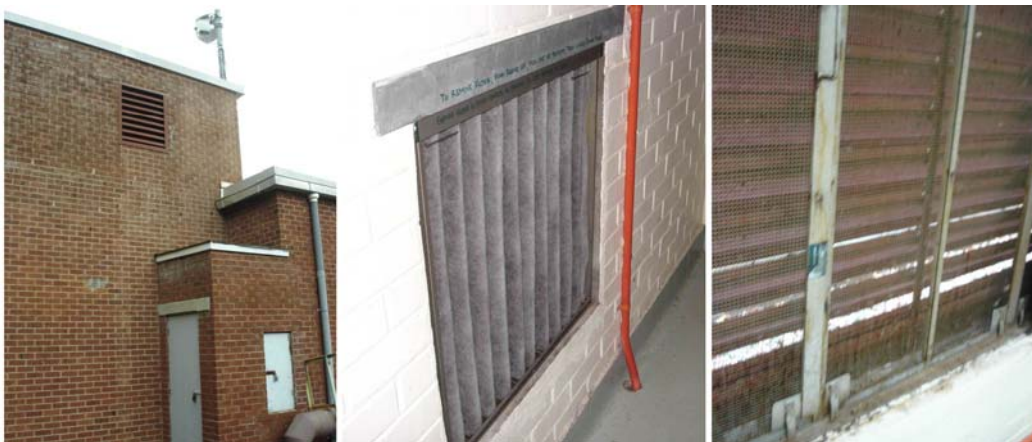
During ashfall the ingress of ash into pump stations will be possible through windows, doors and other ventilation openings, even if the roof remains structurally sound. Vents allowing air into PS16 have either coarse or no filtration and there are gaps around doors (figure 6.21).

*Figure 6.21: External and internal vents with either coarse or no filtration at PS16*

The entry of ash into this facility has the potential to cause problems for the electronic control equipment for the pumps, and to the pump motors themselves. The control equipment, including the programmable logic controller (PLC) and switchgear, while situated in a separate room from the pumps, also uses vents with either coarse or no

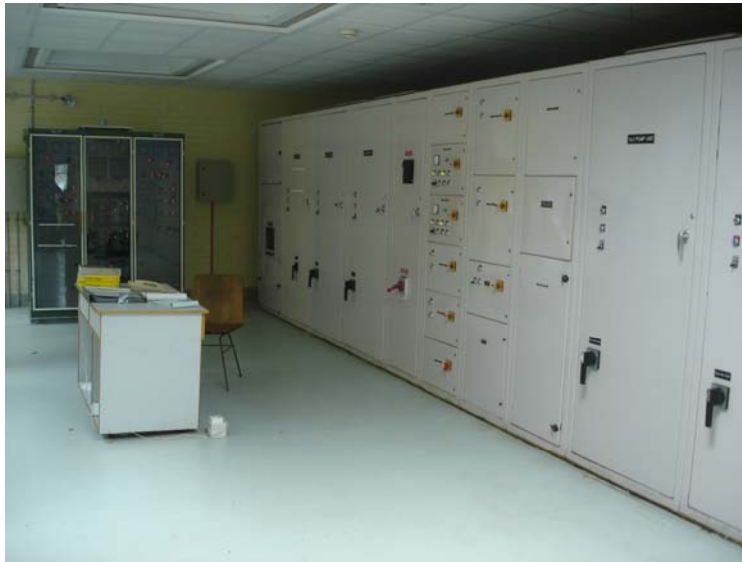
filtration. Small amounts of ash may penetrate these openings, especially in windy conditions. The conductive properties of fresh ash (especially when damp) give it the potential to cause arcing and thus short-circuiting of electrical equipment. Frequent inspection will be required to closely monitor any accumulation of ash in such areas, unless filtration of vents is improved, and seals are installed around doors and windows. This is likely to occur with the current construction of pump station 64, replacing PS16.

*Figure 6.22: PS16 control room and switchgear*

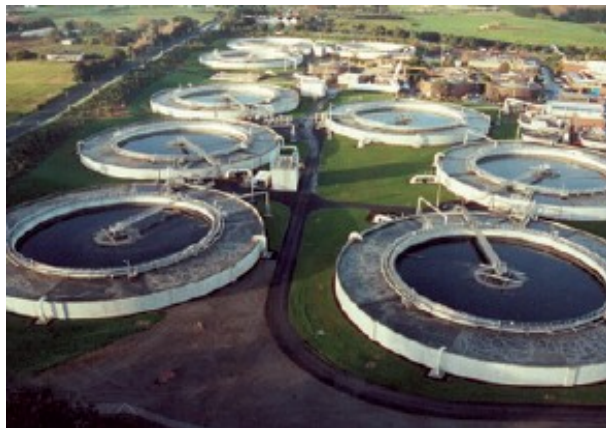
Nine reactor/clarifiers are on site at Mangere, each with a diameter of 77 metres (figure 6.23). Within these systems bacteria strip out organic pollutants. This process is currently the most widely used sewage treatment process worldwide (Watercare, 2009). The balance of the pH in this process is critical though; should the pH fall below 6.5 bacterial conversion of nitrate(s) into nitrogen ceases. Any influx of ash into the treatment plant will likely be accompanied by highly acidic leachates. Although Watercare carefully balance pH, as under normal circumstances acidic effluent enters the system, ash leachates will potentially have sufficient volume and acidity to overwhelm countermeasures taken to increase the pH in the reactor/clarifiers.

*Figure 6.23: Reactor/clarifiers at Mangere wastewater treatment plant*

Acidic ash leachates and acid rain will not only cause corrosion to exposed metal infrastructure, but alter pH levels in the 9 reactor/clarifiers. Each of these units is made up of a series of eight compartments – four aerobic compartments which are aerated, and four anoxic. Under aerobic conditions, biochemical oxygen demand is reduced and ammonia is converted to nitrate and nitrites. Under anoxic conditions, bacteria convert the nitrate and nitrites into harmless nitrogen gas. Should the pH fall below 6.5 bacterial conversion of nitrate(s) into nitrogen ceases, and this type of treatment ceases to function. The reactor/clarifiers each have a diameter of 77 metres, and are open to the sky. They are therefore capable of collecting a lot of ash or acid rain. Once this occurs, pH changes are likely. The pH levels will therefore need to be continuously monitored and countered.

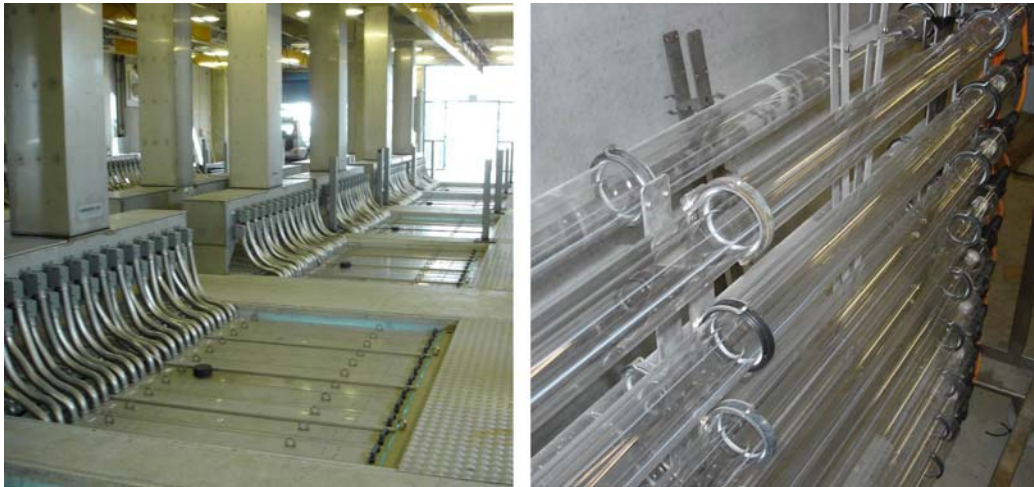
The ultraviolet disinfection process involves passing wastewater through 12 parallel channels, along which arrays of UV lamps are arranged in rows. The lamps are submerged lengthways along the direction of flow, and are encased in quartz tubes (figure 6.24).

*Figure 6.24: UV disinfection facility at Mangere wastewater treatment plant (left). Quartz tubes used to protect UV lights (right)*

These lamps are designed to achieve a 10000x reduction in the amount of pathogens discharged from the treatment plant. The presence of fine volcanic ash particulates

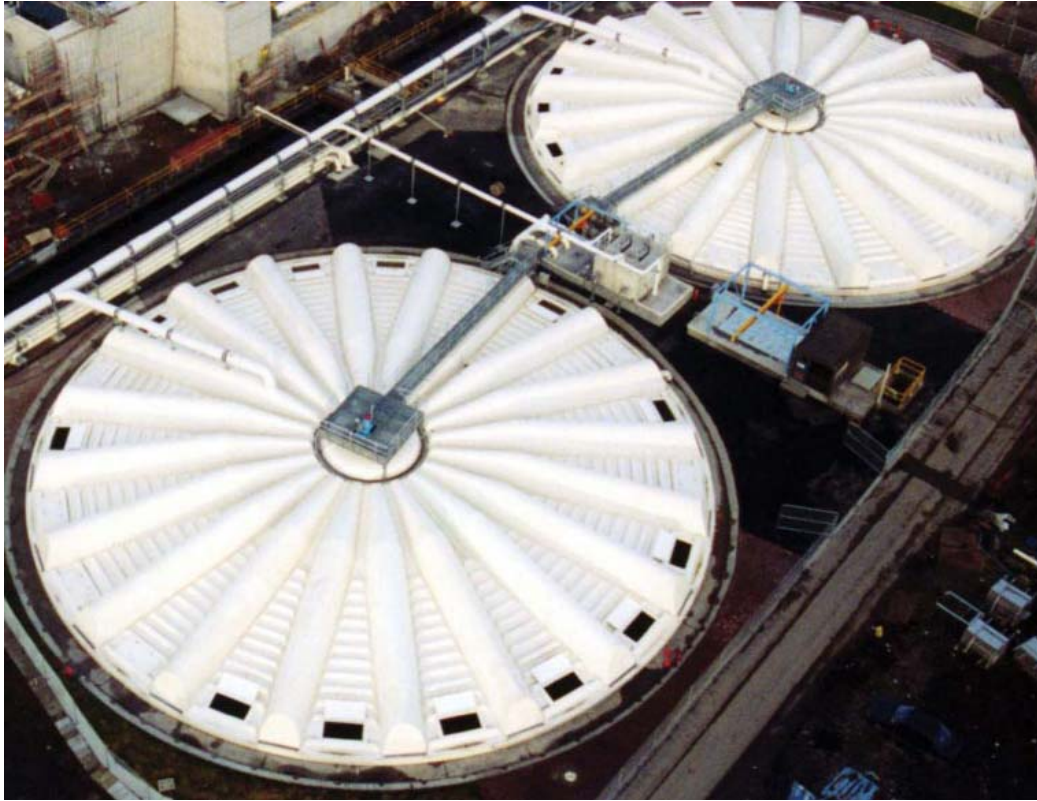
The primary sedimentation tanks, anaerobic sludge digesters and gravity thickeners are all roofed. There is a lack of data on the effects of loading on these types of structures. Rapid removal of ash during any ashfall over 5 cm thick would be advisable. Due to the irregular shape and corrugations of the gravity thickener roof, ash will likely prove laborious to remove from this structure (figure 6.25).

*Figure 6.25: Gravity thickeners at Mangere wastewater treatment plant (Watercare, 2009)*

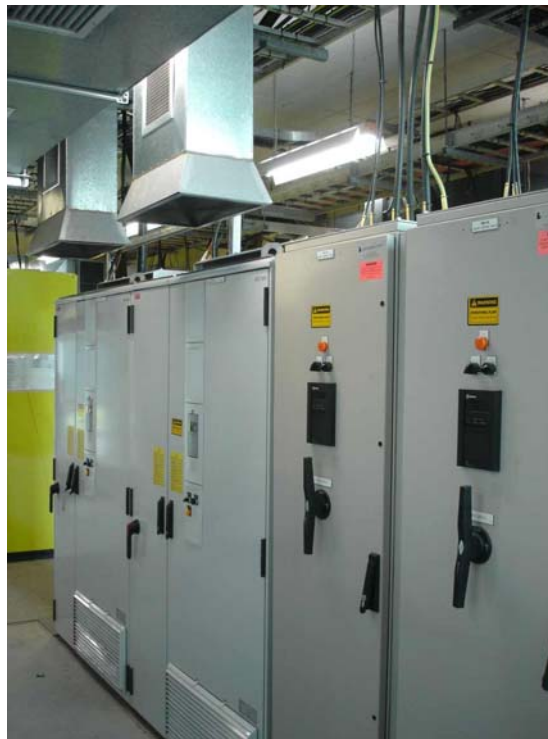
Although the control room uses air-conditioning, the interstage pump station distributed control system (DCS), and switchgear for the odour control fans are housed in other buildings which only use unfiltered fresh air vents and fans. These are situated in the ceilings of the rooms that house this equipment, and often directed at that equipment (figure 6.26). This creates a vulnerability even to light ashfall, as this would result in the ingress of ash into these buildings.

*Figure 6.26: Switchgear for the DCS (left) and odour control beds (right). Note the air vents directly above the DCS cabinets.*

Odour control fan switchgear cabinets are well sealed; ash around these would simply make a mess, and possibly cause minor corrosion to cabinets. DCS switchgear cabinets are vented. Ingress of ash into these cabinets ash will have the potential to cause electrical shorts. This is more likely to occur with damp ash, as ash becomes conductive when wet (Gordon et al., 2005). As these cabinets generate a lot of heat, ash would quickly dry, lessening the chance of shorts occurring. Ash inside the cabinets is still not desirable; apart from the (low) chance of electrical shorts, corrosion is possible in the longer term, and abrasion or binding of moving parts (e.g. switches) will be likely.

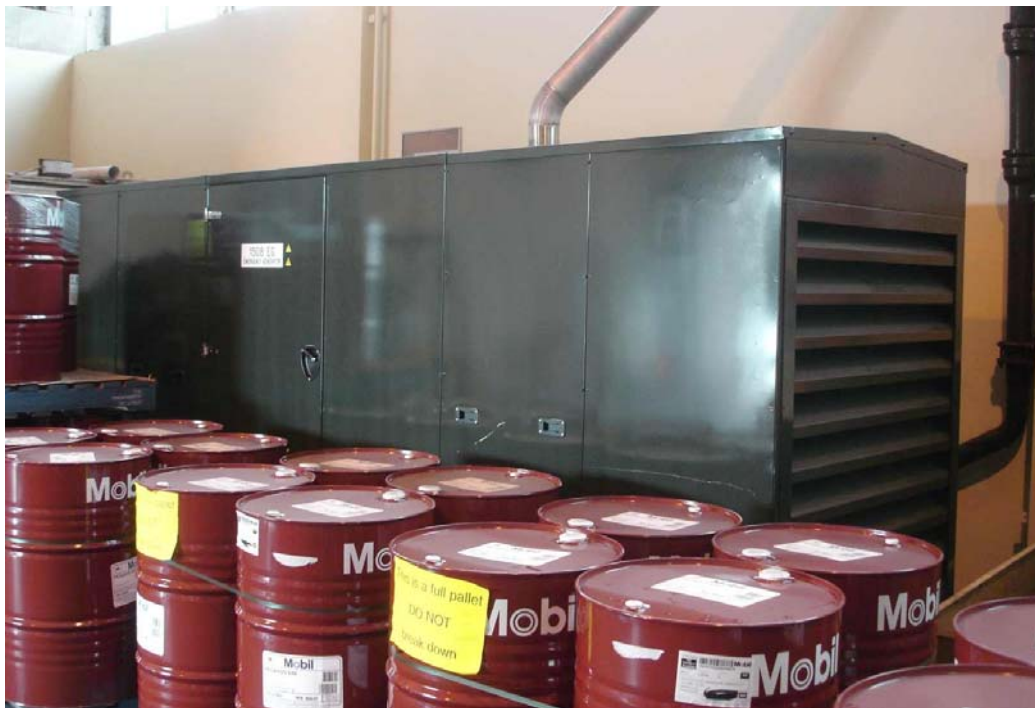
In the event of power failure, on site generators can run the plant at up to 50% capacity. Some treatments are not used as a result. There are two forms of onsite power. Two backup generators run on diesel (figure 6.27) but the plant also has Four Jenbacher JMS 616 turbo-charged gas engine/generators. These produce almost 7 MW in total, and run on biogas produced by the anaerobic digesters. They are also able to run on natural gas as a backup. These generators will be useful in the event of power failure caused by ashfall in other locations, but may be slightly compromised in the event of direct ashfall on the plant. This is due to the need for air for combustion; the constant supply of air required means that air filters are likely to be blocked as ash is ingested. The generators will require regular maintenance and filter cleaning in this instance.

*Figure 6.27: Back up generator and fuel supplies at Mangere treatment plant*

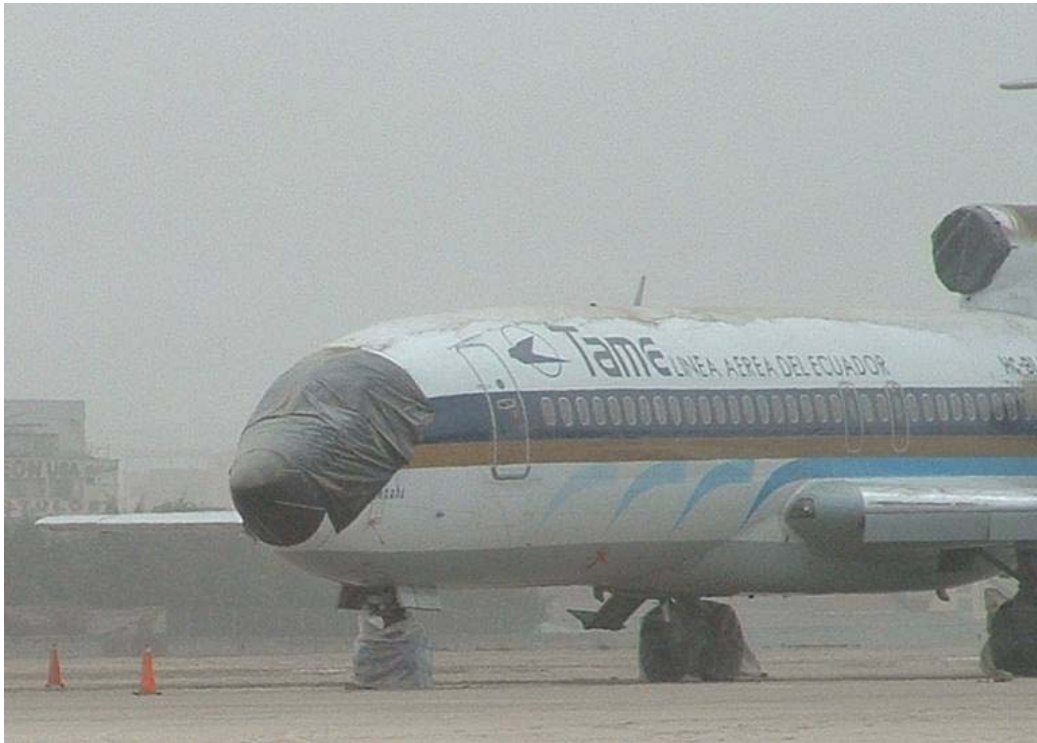
Where possible, it is preferable to move aircraft pre-eruption rather than trying to cover them up or park in hangars. If an eruption becomes prolonged, or the airport is closed for several days, the aircraft may be trapped on the ground. This happened to the Ecuadorean airline TAME, during the 2002 Reventador eruption, when 7 of the airlines fleet of 11 aircraft were trapped on the ground for the duration of the clean-up (figure 2). This caused major financial losses for the airline (Leonard et al., 2005).

*Figure 2: Boeing 727 with makeshift covers during ashfall, Quito, November 2002, photo courtesy Mariscal Sucre Airport.*

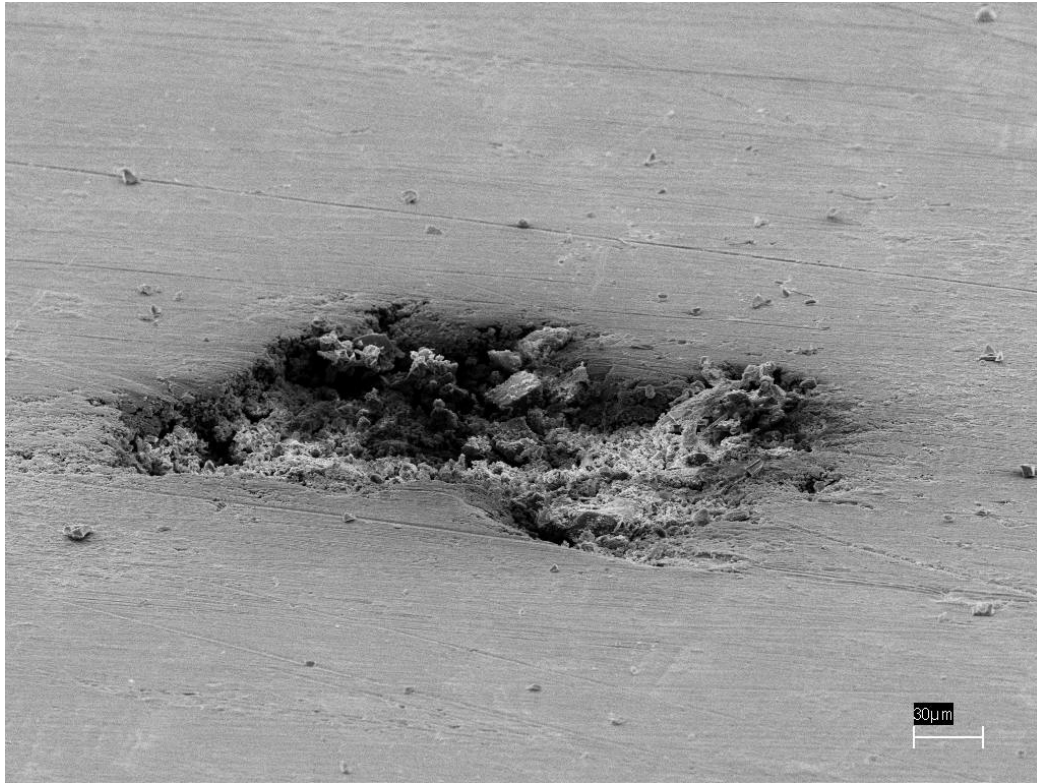
with an ash leachate of pH 2.5 resulted in surface pits of 10-30  $\mu\text{m}$  after 24 hours, clad surfaces experienced deeper pitting of up to 50  $\mu\text{m}$  (figure 3) (Barnard, 2009).

*Figure 3: SEM micrograph of clad 2024-T3 aluminium after being exposed to a leachate of pH 2.5 for 24 hours*
